**HISTORIC RESOURCE DOCUMENTATION
COLCHESTER MILL POND DAM REMOVAL PROJECT
(DAM STATE ID 51.02)
COLCHESTER, CHITTENDEN COUNTY, VERMONT**

Kate Kenny
and
Catherine A. Quinn
University of Vermont
Consulting Archaeology Program
111 Delehanty Hall
180 Colchester Avenue
Burlington, VT 05405

Report No. 1218

November 19, 2019

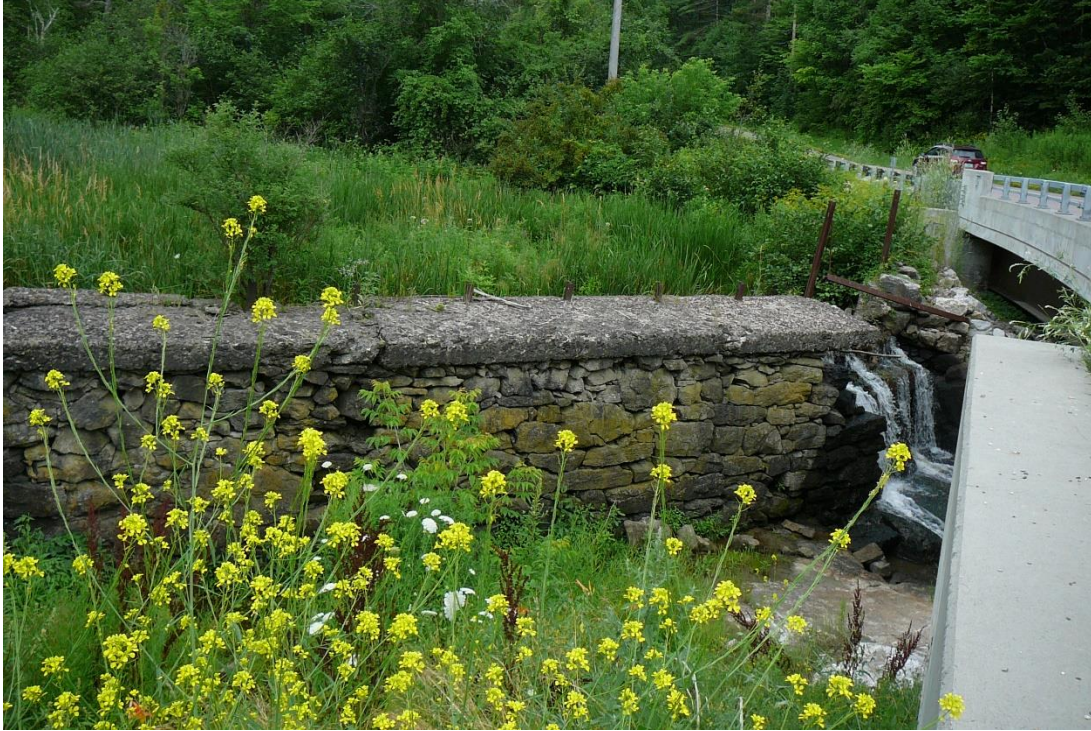
Figure 21. View southwest of the secondary (stone masonry portion) and primary spillway (breached portion) sections of the Mill Pond Dam.

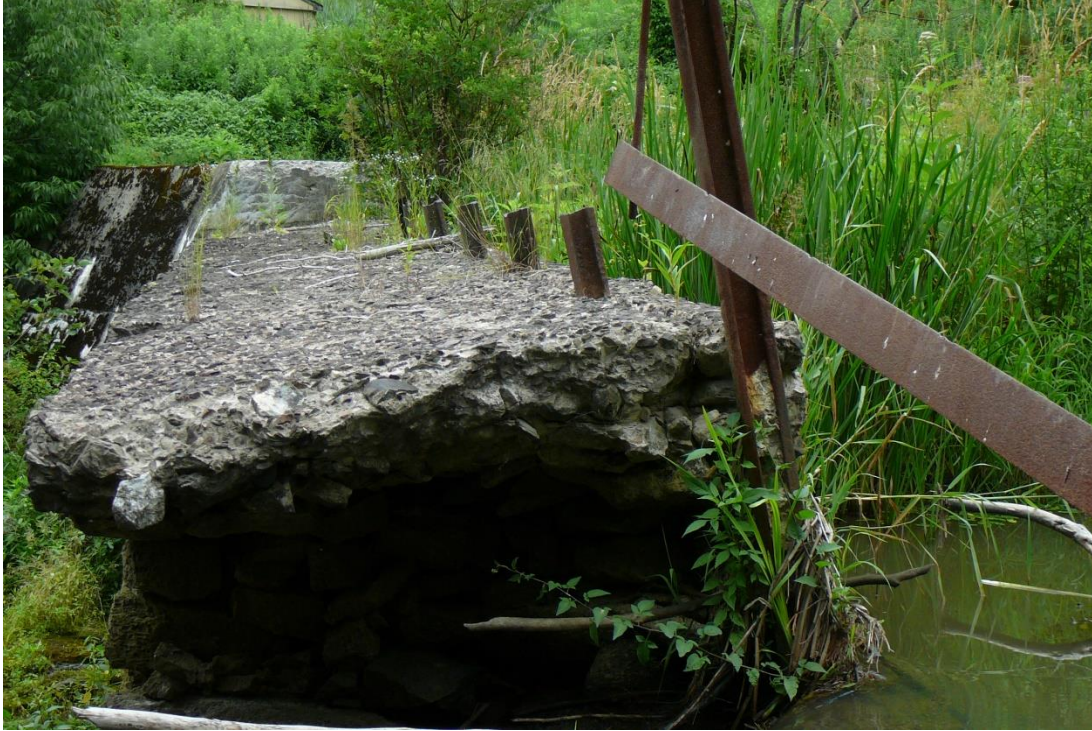
In the late 19th or early 20th century, this section of the structure was capped and faced with concrete (Figure 23 and 24). The concrete cap is about 1 ft thick (DuBois & King 1990: Plate #3). It appears that the application of concrete was carried down the upstream (water) face and along the entire length of this part of the structure, presumably to provide a watertight surface. The upstream face appears to be slightly battered. Embedded into the concrete along the upstream face are a series of light stock railroad rails set nearly vertically at about 5 ft intervals (on center), but angled slightly downstream (Figures 25 and 26) (DuBois & King 1990: Plate #2 and #3). Most of these have been cut down from their original length since they were installed (see Figures 23 and 24). The rails do not appear to be related to flashboards, but rather may have been placed to catch large pieces of ice/floating debris at the upstream side of the dam that managed to bypass a boom placed for that same purpose further upstream. The broad crest of the masonry section of the dam may have been vulnerable to damage if ice or large debris caught on top.

Figure 23. View east of the concrete cap on the secondary spillway section (stone masonry portion) of the Mill Pond Dam.

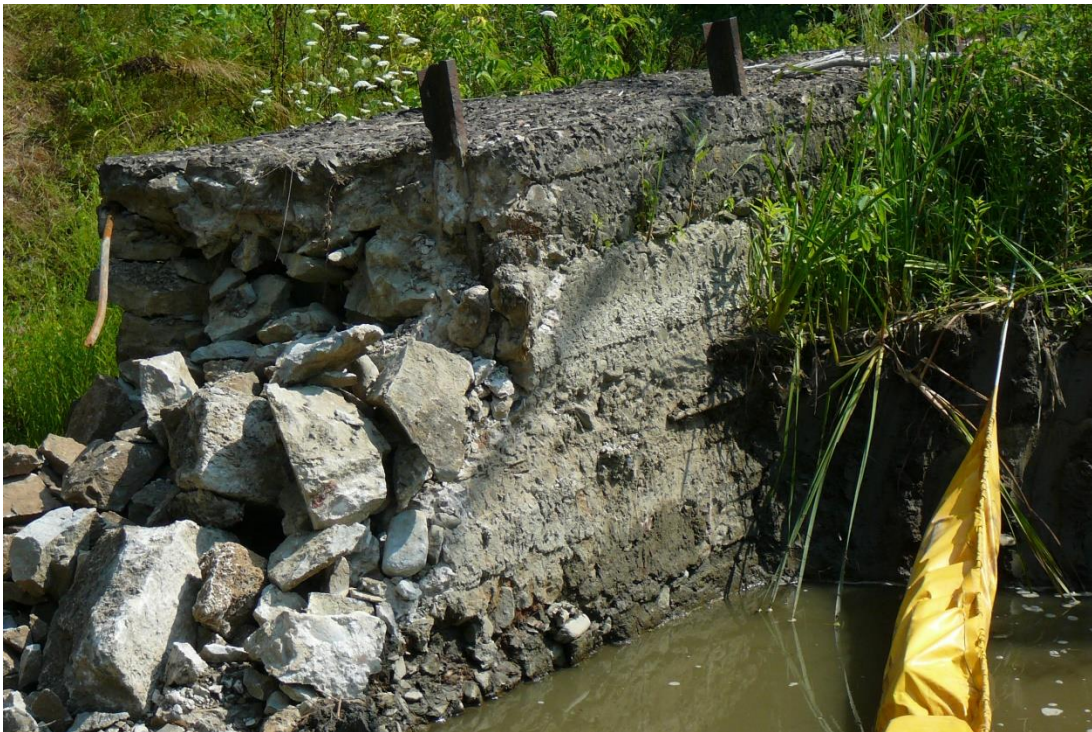
Figure 24. View east of the concrete cap and upstream facing on the secondary spillway section (stone masonry portion) of the Mill Pond Dam, during deconstruction.

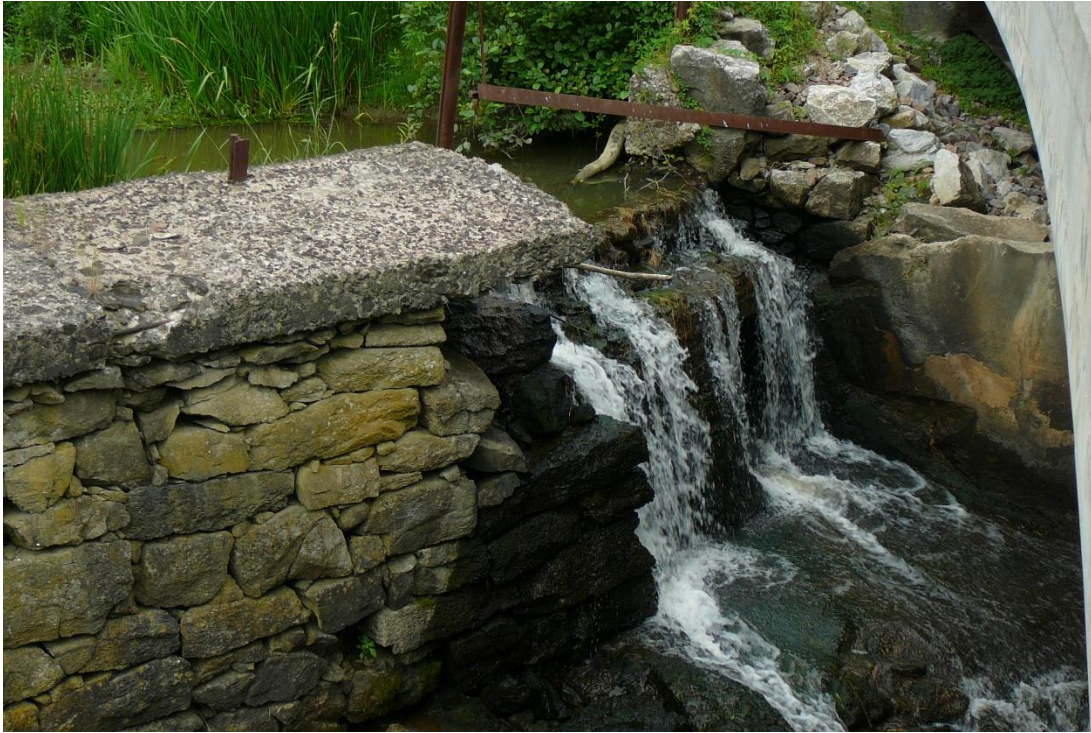
To the west of the above described section was the principal spillway, a 11.5 ft concrete weir that is now partially breached (Figure 27; see Figure 21) (Bushman and Carpenter 2011; DuBois & King ca. 1989; DuBois & King 1990:2, 4, Plate #2 and #3). From previous surveys, it appears that the crest height of the primary spillway was set at 8.0 in lower than the secondary spillway, but “had provisions” for stop logs to make its elevation equal to the secondary spillway (Barranco and Fitch 1975; DuBois & King ca. 1989; DuBois & King 1990: Plate #2 and #3). The crest width or thickness of this section was reported to have been 2 ft and the base thickness 3.5 ft (DuBois & King 1990: Plate #2 and #3). In 2003, it was reported that there are two rectangular outlets located “at the base of the dam, directly below the spillway” (Lamoureux & Dickinson 2003:3). These outlets were reportedly “blocked in recent times by sheets of plywood covered with fill” (Lamoureux & Dickinson 2003:3). This was probably done in an effort to maintain the level of the pond for recreational uses. However, a rough sketch of the dam made in 1980 appears to indicate that there is one “2 x 2 ft waste gate” (aka, low outlet, flood, drain, sluice, or draw down gate) at the base of the primary spillway section (Barranco 1980). This gate would have been used to draw down the mill pond to make repairs on the dam, scour sediment, vent flood waters, or fluctuate the level of the pond in order to kill weeds and/or mosquitoes. This low outlet opening was exposed during the dewatering/deconstruction; it appeared to have horizontal wood boards blocking it, possibly the remnants of a wooden gate (Figures 28 – 30).

Figure 27. View southwest of the breached primary spillway section of the Mill Pond Dam, from Bridge No. 12.

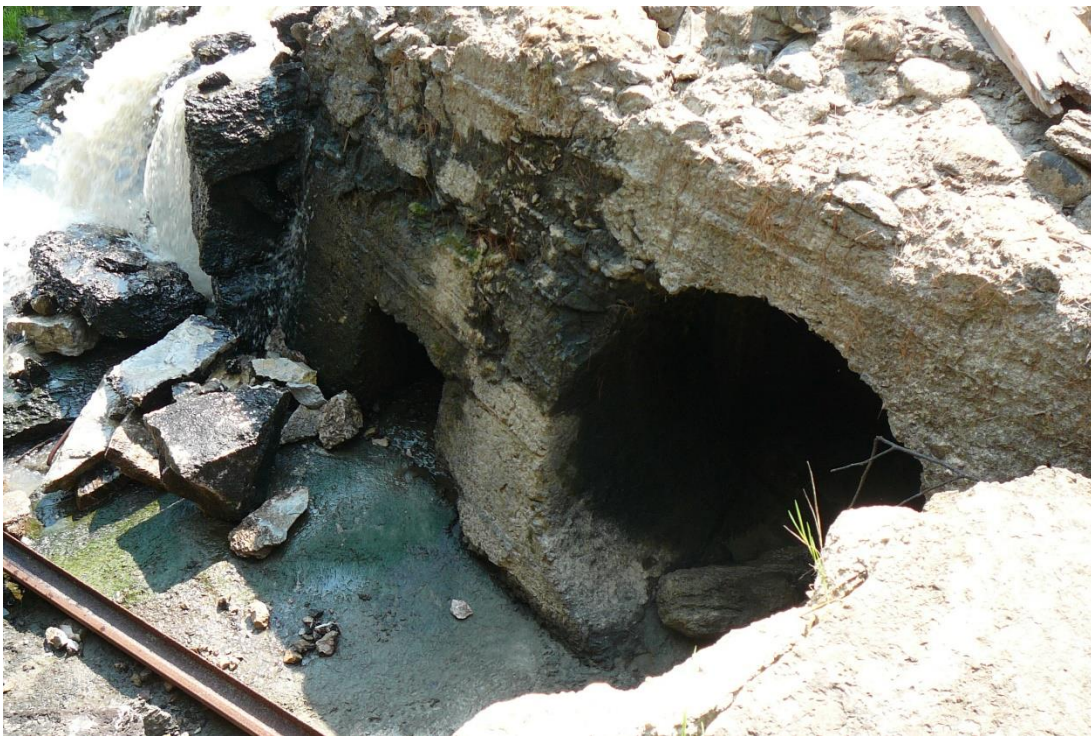
Figure 28. View east of the primary spillway section of the Mill Pond Dam during deconstruction with low outlet gate (left) and penstock (right) openings exposed.

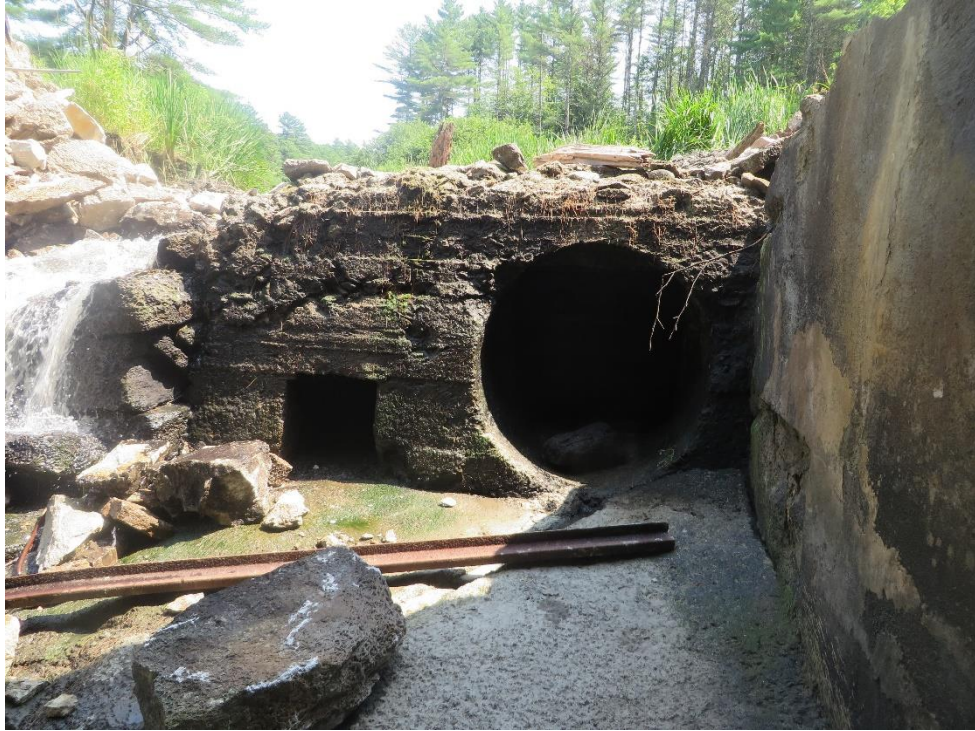
Figure 29. View southeast of the primary spillway section of the Mill Pond Dam during deconstruction with low outlet gate (left) and penstock (right) openings exposed.

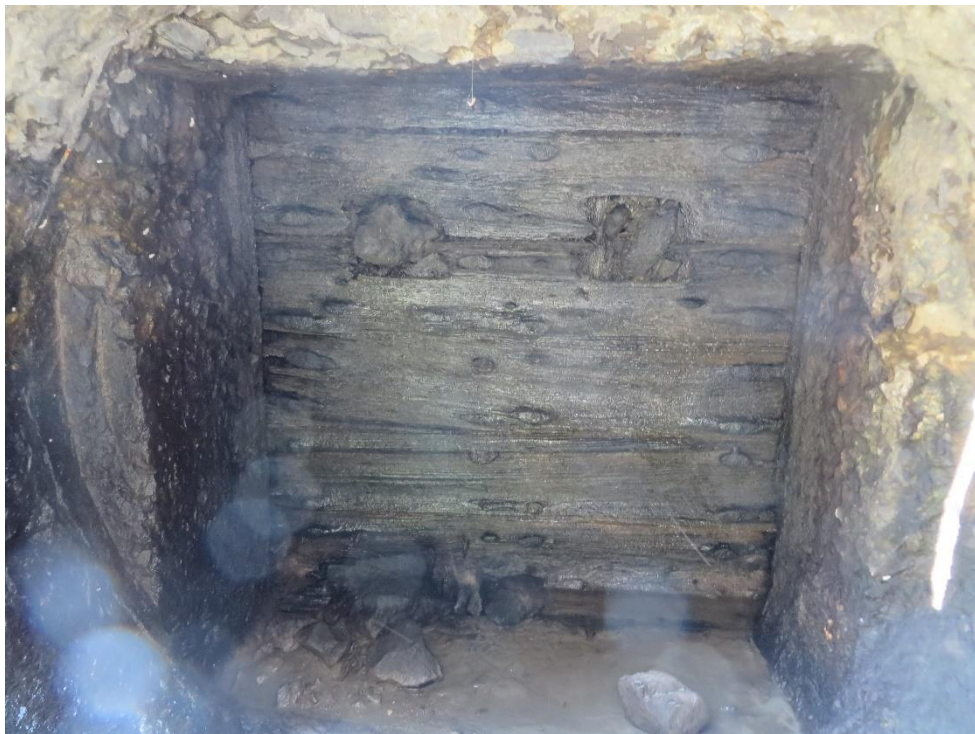
Figure 30. View southeast of wooden boards within the low outlet gate opening in the primary spillway section of the Mill Pond Dam during deconstruction.

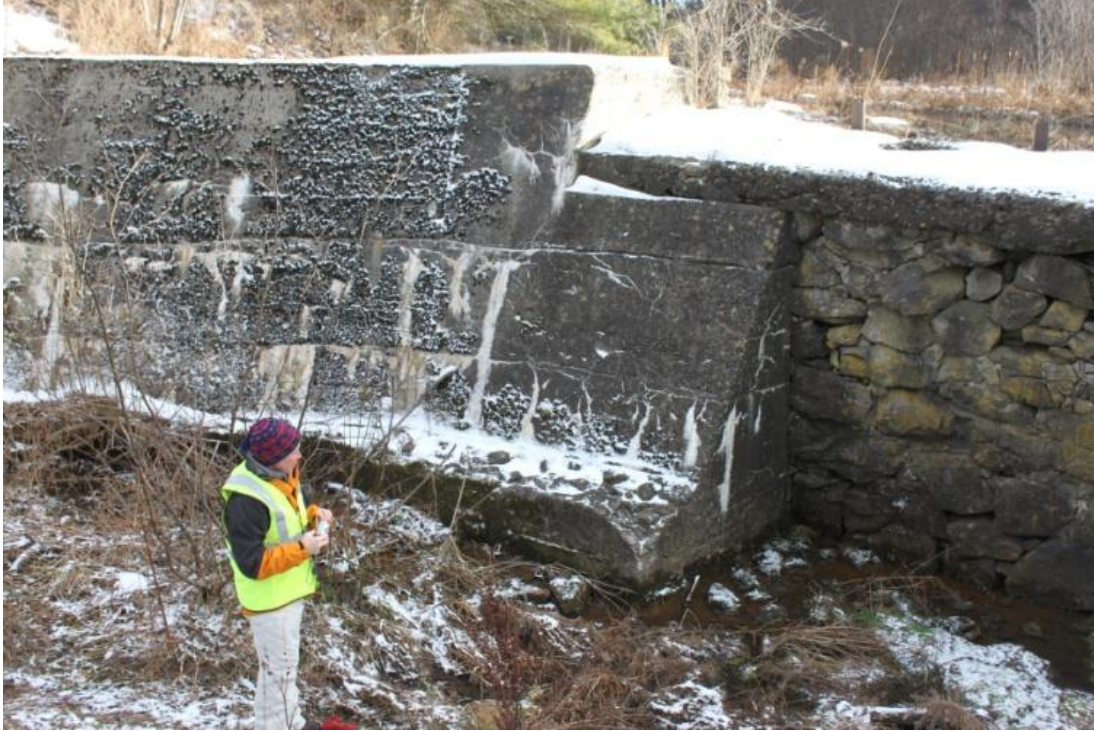
Figure 34. View east of the junction between the stone masonry and the mass concrete sections of the Mill Pond Dam; note concrete “buttress” at center.

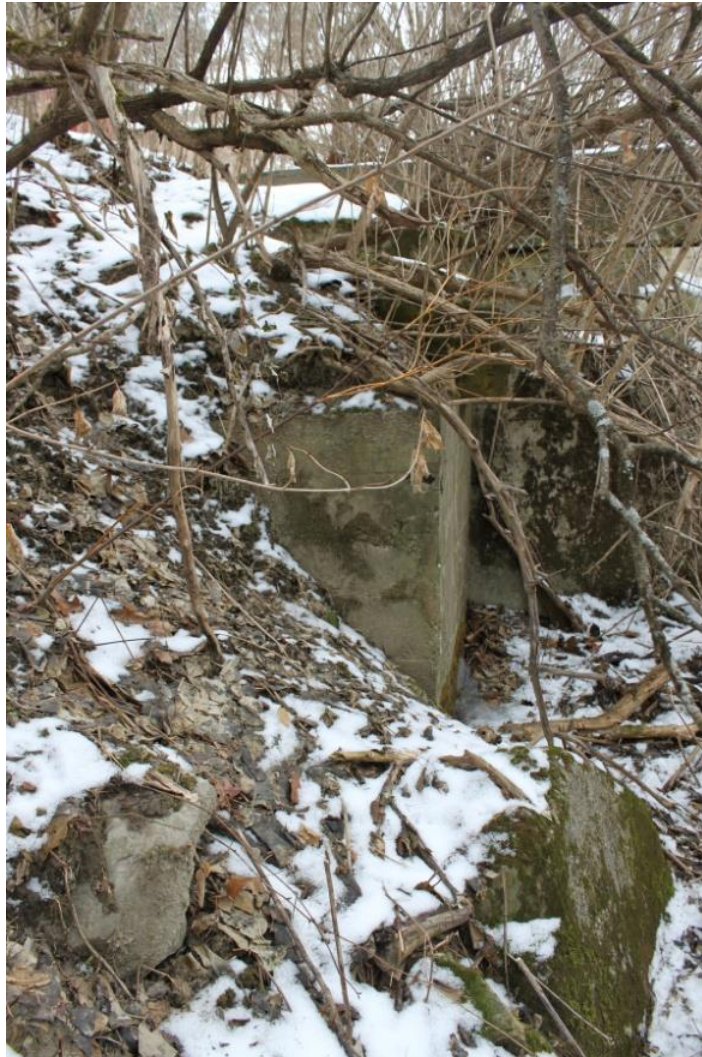
the east end of the wing there is a large concrete stepped baulk that is partially buried in the bank (Figure 36). The visible part of the baulk extends about 11 ft downstream and it is minimally 3.75 ft wide (Dubois & King 1990: Plate #2). At the west end of the mass concrete section, is the 5.3 ft of buttress-like section that stands on the downstream side of the central stone masonry section (Figure 37; see Figure 34). The contractor who removed the dam reported that the mass concrete section contained a lot of rock and contained no rebar (Figure 38).

Figure 36. View southeast of the downstream side of the right (east) wing and abutment area of the Mill Pond Dam showing the concrete stepped baulk partially buried in the bank.

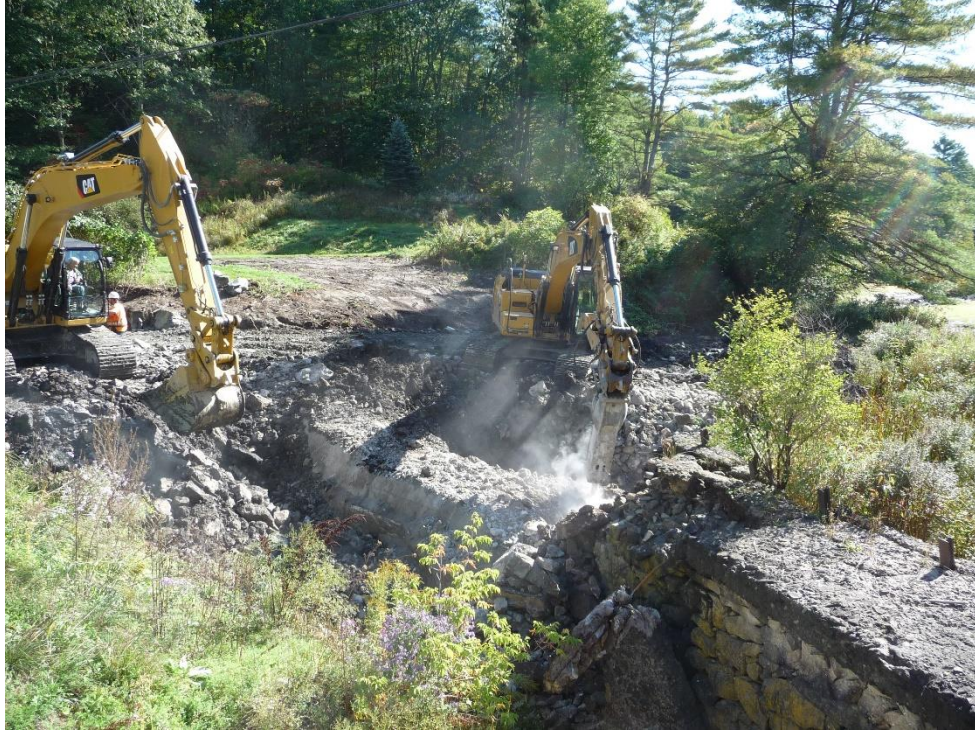
Figure 38. View southeast during the deconstruction of the mass concrete section of the right (east) wing of the Mill Pond Dam.

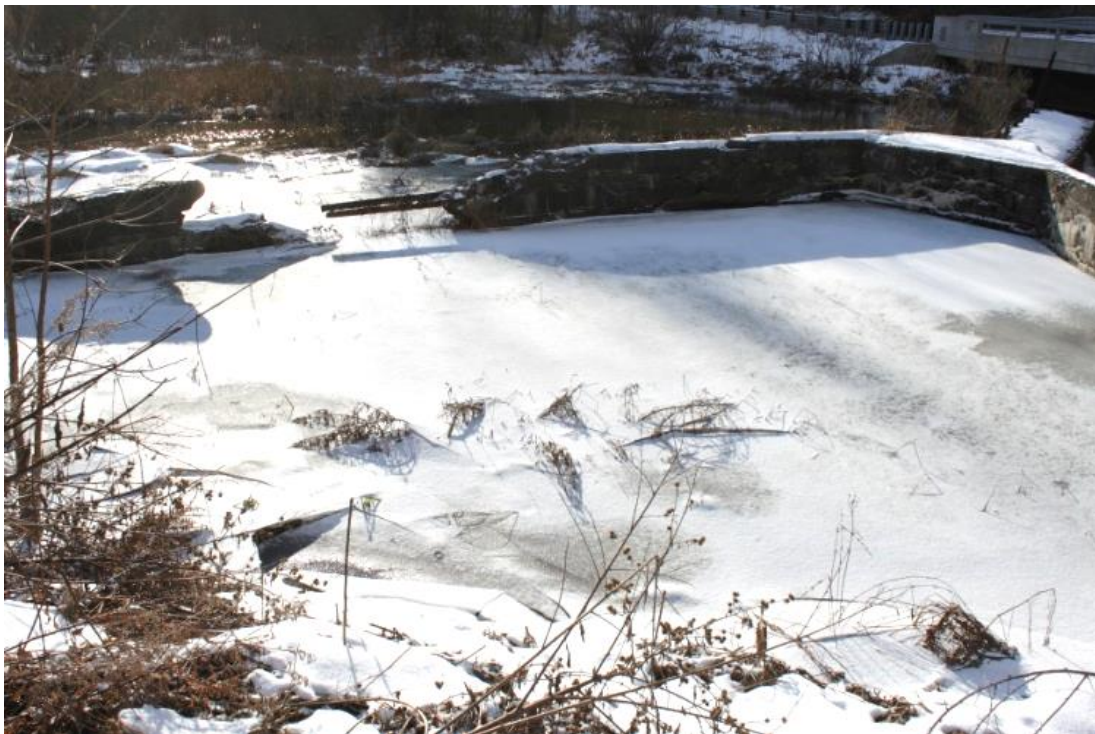
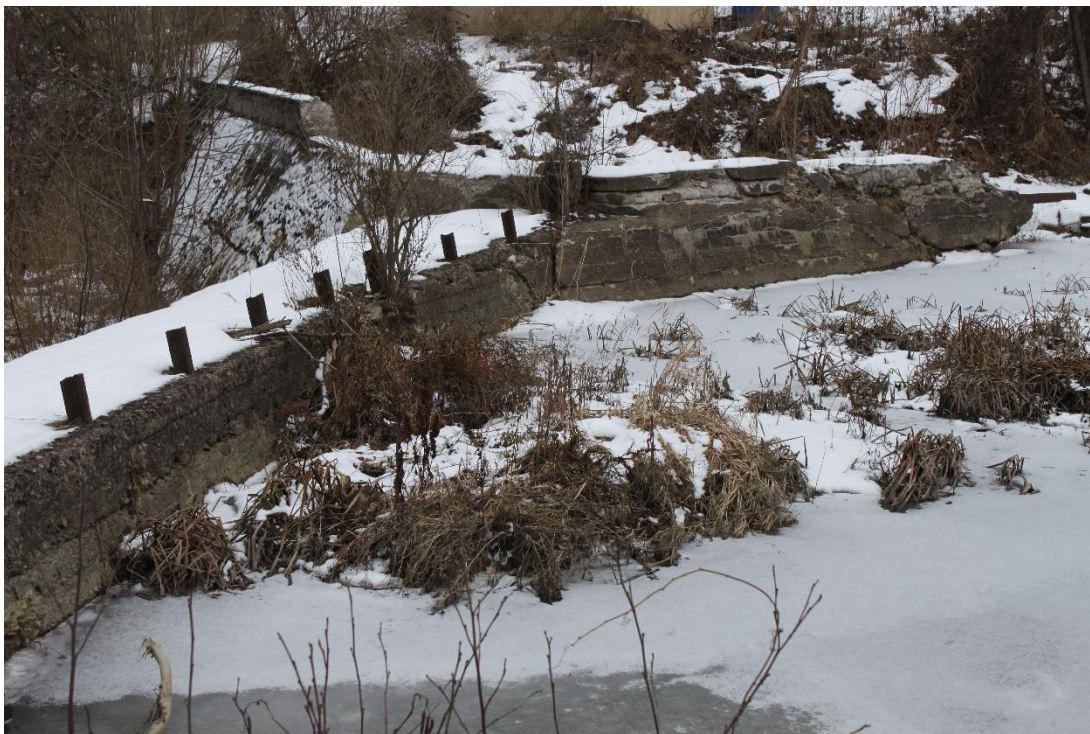
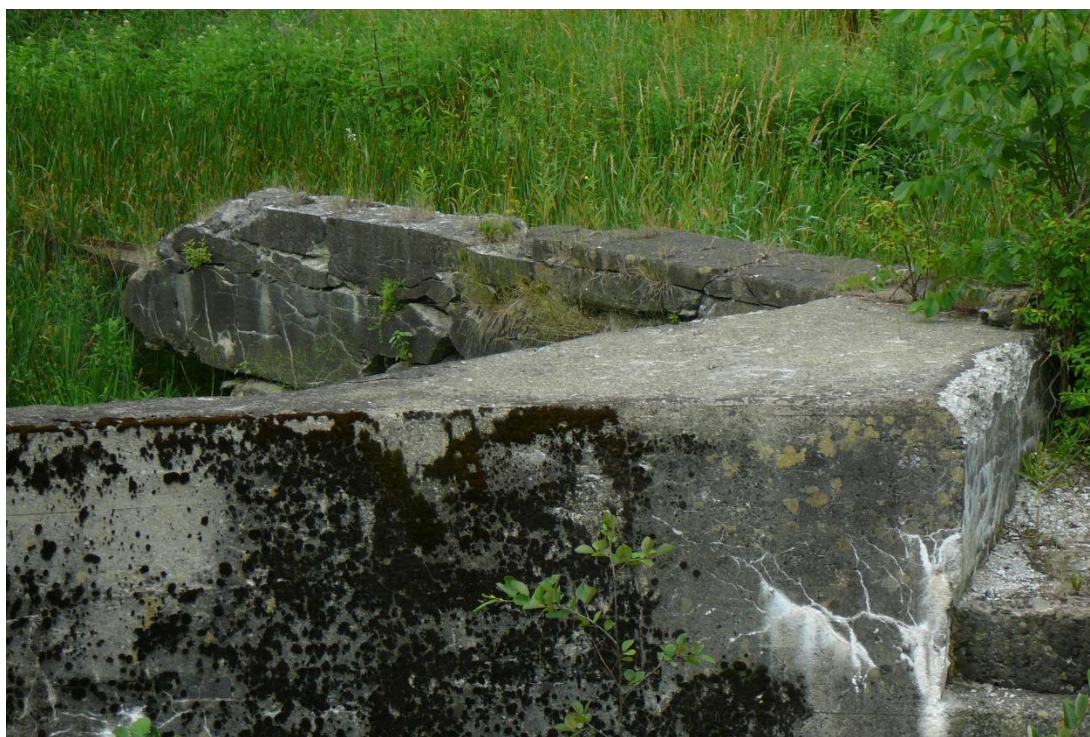
The upstream part of the east side of the dam is a *possible* concrete training wall (Figures 39 – 41). Although it was once estimated at 75 ft long, presently only about 46 ft of it is traceable (Dubois & King 1990: Plate #2; Milone & MacBroom 2018). This feature has a crest width of 2 ft and appears to have vertical sides (Dubois & King 1990: Plate #2). Some parts of this structure have settled and are partially submerged and other parts are simply missing (Barranco and Fitch 1975; Terhune and Pollock 2007). The broken sections show exposed horizontal reinforcing steel, possibly flat reinforcing bars. One team of state dam inspectors noted that the truncated Y shaped structure appeared to form a forebay, but also noted that “there are no signs of any headworks & etc.” in that part of the structure (Barranco and Fitch 1975). It is possible that the right (east) side of the dam may represent (at least in part) an artificial abutment, constructed where there was no longer a suitable natural abutment after the 1927 flood (see Figure 26).
