## Capital Improvements

Capital improvements are an important part of our overall plan to address water quality issues in Colchester. Without a sound storm water infrastructure, there will continue to be a degradation of our waters. Repairing storm water outfalls, installing storm water treatment ponds and performing other storm water pollution projects is a difficult and expensive initiative. Subsequently, within our overall capital planning, we have made these types of projects a priority. An important part of our strategy involves securing the necessary funds to build these projects. Over the past several years, the Department has established a strong working relationship with the offices of Senators Leahy and Jeffords. With the assistance of these long time State Senators, we have secured over \$3 million in federal funding to improve Colchester's waters. Included below are some of the projects that have been completed through these efforts.

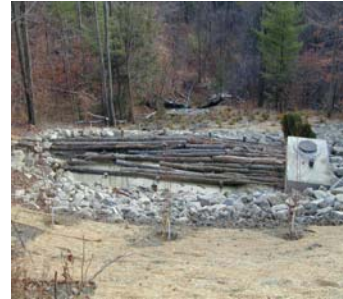
**Canyon Estates** - In Canyon Estates, a 75 lot residential sub-division, a storm water outfall failed causing substantial erosion. An innovative design was used to reconstruct the outfall that relied upon extensive vegetation to stabilize the steep slopes. Left, heavy equipment positions a large concrete vault about half way down the slope. The storm water is piped to this vault, where it is released

into a sedimentation pond. Below right, is the completed sedimentation pond that uses a series of logs that serve as a weir to distribute the water evenly down the remaining slope. The slope has been heavily stabilized with aggressively rooting vegetation. Over time, the logs deteriorate resulting in re-vegetation and the development of a natural weir. During construction, we had the privilege of being visited by Senator Leahy who had secured funding for this project.

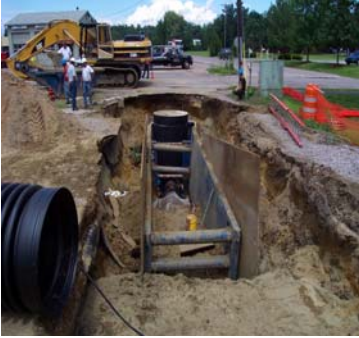
**The Moorings** - The Moorings outfall is located on the inner bay, and collects runoff from the Diversity Hill area and the Shore Acres sub-division. Ongoing water quality monitoring data collected by the Town continued to identify this outfall as a source of bacterial pollution. With much of the bacteria attaching itself to sand and other solids within the storm water flows, the Public Works Department designed a "Baffle Box" which effectively traps the sediment in a large concrete vault, without interfering with the storm water flows. At the end of each summer during low water, a vacuum truck is used to remove the accumulated sediment from the box. The structure was designed by Colchester Town Engineer, Genie Soboslai, P.E., (now retired). Half of the project funding came from an environmental fine on a Colchester business by the State of Vermont. At left, Genie is shown standing next to her creation.

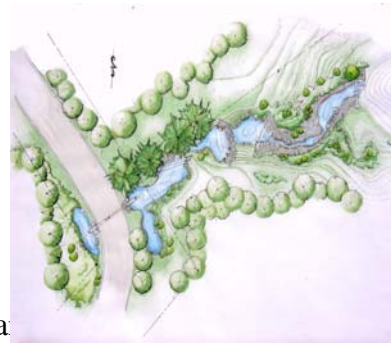
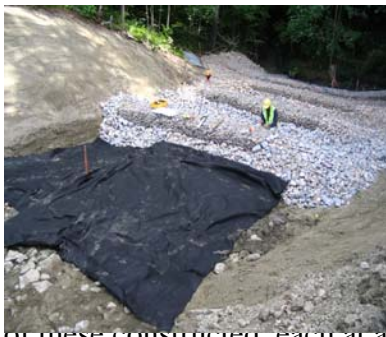
**Shore Acres** – Shore Acres is a 70 lot residential sub-division, which in addition to the lots, collects storm water runoff from the Diversity Hill area. The primary outfall from this sub-division had failed, causing substantial erosion and sediment transfer into the receiving stream. The stream eventually drains to the inner bay where the Town is very concerned about water quality. In addition to the erosion problems, the failure and inadequacy of the outfall was also causing localized flooding during high

flow periods as is seen in the upper left photo. Design efforts began with the goal of developing improvements that would ease the localized flooding, provide pre-treatment of the storm water before discharging it to the stream, and slowing the velocity of the water down to prevent future erosion. A concept design was produced that accomplished these goals, with careful consideration to the aesthetic appearance of the

improvements. Unlike many other structures, the location is clearly visible from several of the neighborhood lots. To soften the appearance of the improvements, carefully placed landscaping was incorporated into the design. Construction began and workers carefully assembled the many Gabions that would reduce the velocity of the discharge. Gabions are a basket constructed of heavy steel wire that are filled with rocks about 4” to 6” in size. There were several

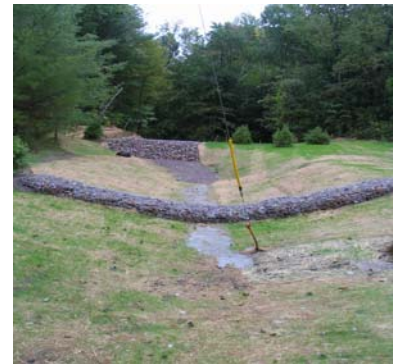
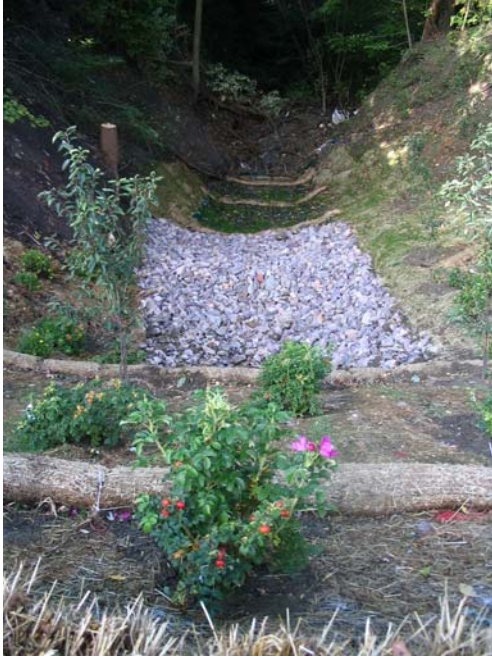
of these constructed, each at a lower level forming a series of steps for the water to flow through. Behind each Gabion was a small settling basin to further treat and slow the flows before discharging to the stream. Before reaching the Gabions, the water flows into a grassed line settling basin where the water is initially held to allow the solids to settle out of suspension, thereby providing pre-treatment of the discharge.

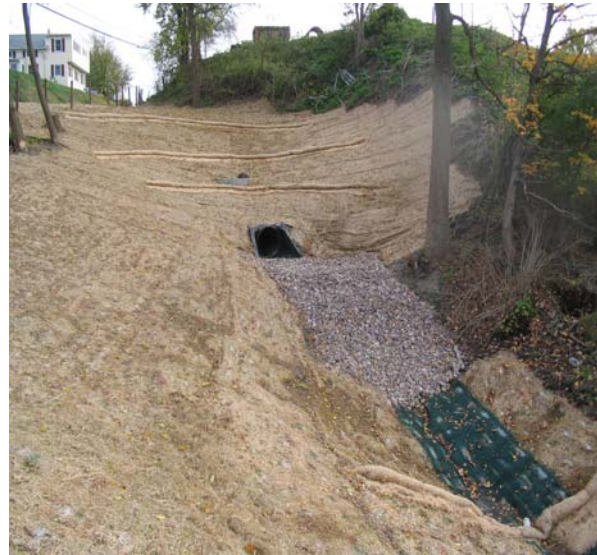
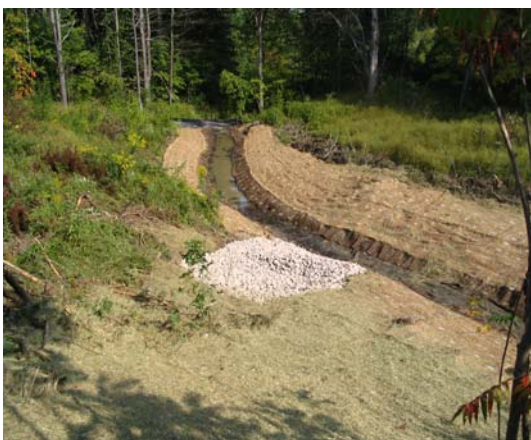
The discharge points south of the roadway are typically old stormwater outfalls that were constructed without any outlet controls or stabilization, and have badly eroded and/or failed as additional flow was introduced by new development.

Town outfalls along this roadway have been repaired using a mixture of design strategies including energy dissipation and various forms of stabilization, with emphasis on the use of natural vegetation. The two photos above show two separate outfalls on Malletts Bay Avenue recently reconstructed by the Town.
