**HISTORIC RESOURCE DOCUMENTATION
COLCHESTER MILL POND DAM REMOVAL PROJECT
(DAM STATE ID 51.02)
COLCHESTER, CHITTENDEN COUNTY, VERMONT**

Kate Kenny
and
Catherine A. Quinn
University of Vermont
Consulting Archaeology Program
111 Delehanty Hall
180 Colchester Avenue
Burlington, VT 05405

Report No. 1218

November 19, 2019

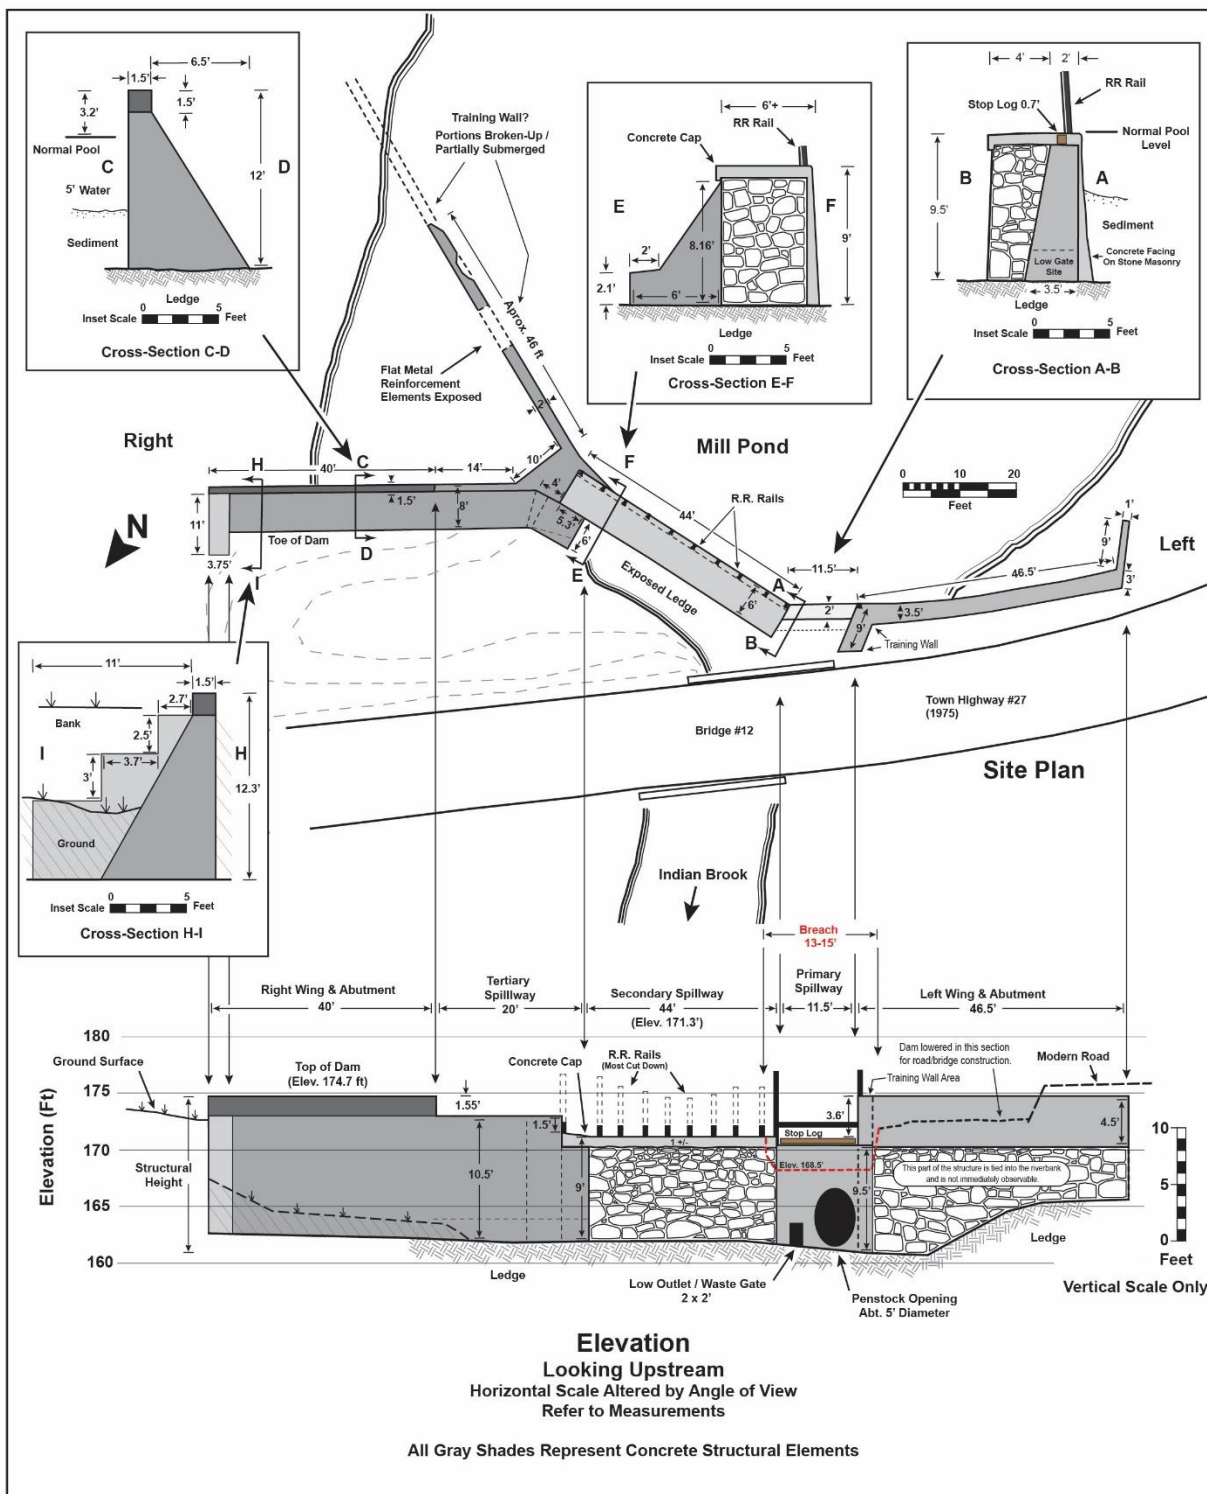
Figure 18. Plan, downstream elevation, and key cross-sections of Mill Pond Dam.

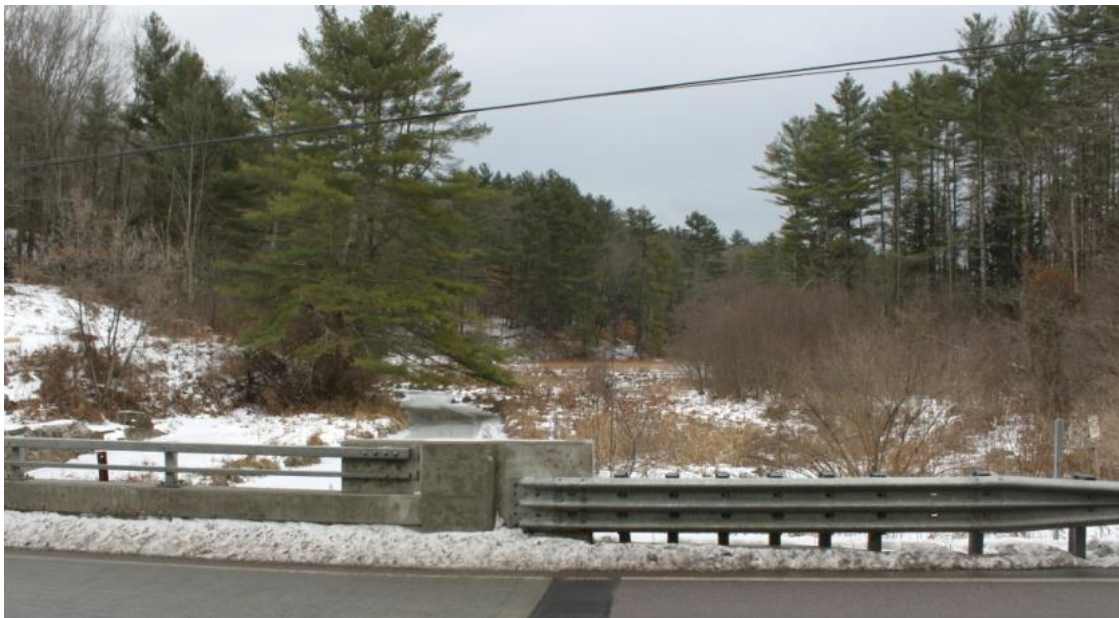
The existing Mill Pond Dam (State ID #51.02) is a combination stone masonry and mass concrete run-of-river (or low-head) gravity structure founded mostly on bedrock and having a watershed area of approximately 6,670 acres (10.4 sq mi) (Figure 18) (Barranco and Fitch 1975; *Burlington Free Press* December 6, 1927; DuBois & King 1990:2, 4-5, Plate #2 and #3; Milone & MacBroom 2018). The present dam reflects a number of significant changes made to the structure through redesign and/or necessary repair. The crest length, or the overall developed length of the top of the dam, is approximately 169 ft (Milone & MacBroom 2018). Crest widths vary between 1.5 and 6 feet (Barranco and Fitch 1975; DuBois & King 1990:2, 3, Plate #2 and #3). The structural height of the dam, or the vertical distance from the lowest point of natural ground on the downstream side to the highest part of dam that would impound water, is 12.3 ft with the 'top of dam' set at 174.7 ft above sea level (Milone & MacBroom 2018). The exposed natural ledge in the area serves as the apron for the dam. As designed, the dam's height to normal pond level was about 10 ft (3 m), which created an impoundment of approximately 10 acres at about 170.0 ft above sea level (DuBois & King 1990:2, 4; Haybrook 1952:41; Milone & MacBroom 2018). At normal pond level, the impoundment extended upstream along Indian Brook about 2,000 ft (Lamoureux & Dickinson 2003:4) (Figure 19; see Figures 15 – 17). Prior to dam removal, the pond extended only about 170 ft from the dam (Figure 20).

Figure 20. View southeast (upstream) of the former impoundment area of the Mill Pond Dam.

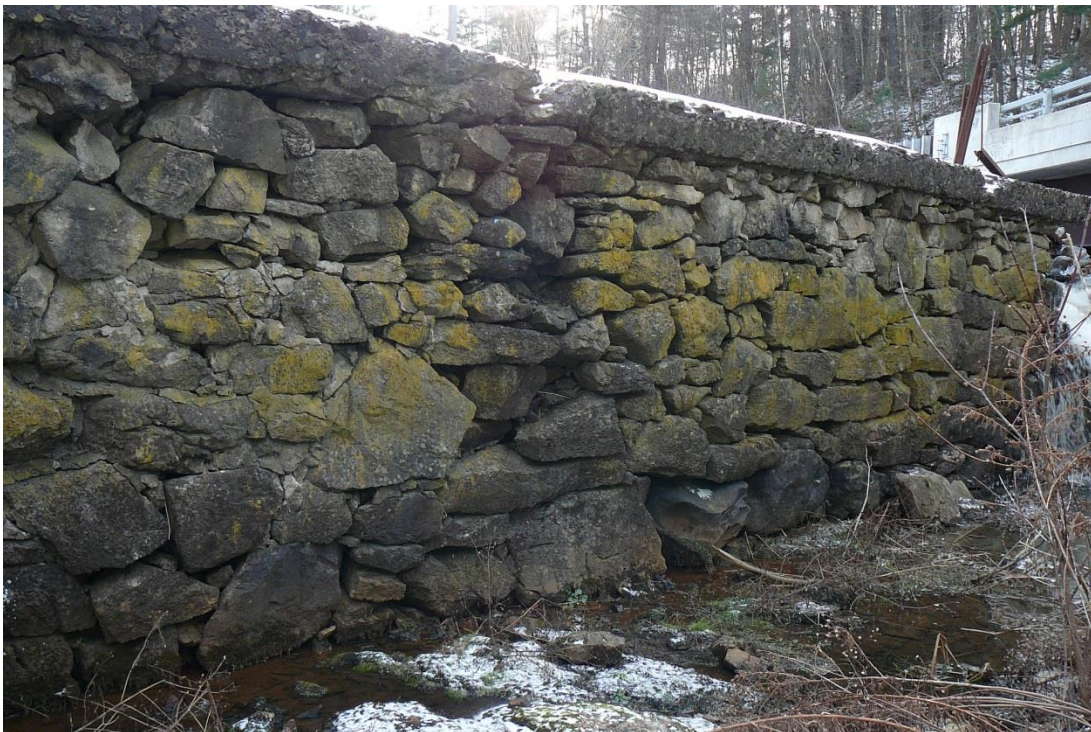
There are several sections to the dam. The central portion is the secondary spillway section (Figures 21 and 22) (DuBois & King 1989 and 1990:4, Plate #2 and #3). This is the oldest part of the structure. It consists of a 44 ft long broad crested stone masonry straight drop weir with a concrete cap and upstream facing (Barranco and Fitch 1975; DuBois & King 1990:2, 3, Plate #2 and #3). The crest width of the secondary spillway is 6 ft and the height of the spillway crest is set at 171.3 ft above sea level (Milone & MacBroom 2018). The base width or thickness of this section is roughly the same as the top (DuBois & King 1990:3, Plate #2 and #3). This section is of rubble stone construction laid without mortar using local stones, most unmodified and/or minimally shaped, generally varying in size from 6 inches to 4 feet, but with a few smaller rocks inserted into joints between the larger stones. There are several areas where mortar or cement has been applied between the stones on the downstream (air) face, presumably in response to water seepage through this part of the structure.

Figure 22. View southwest of the secondary spillway section (stone masonry portion) of the Mill Pond Dam.

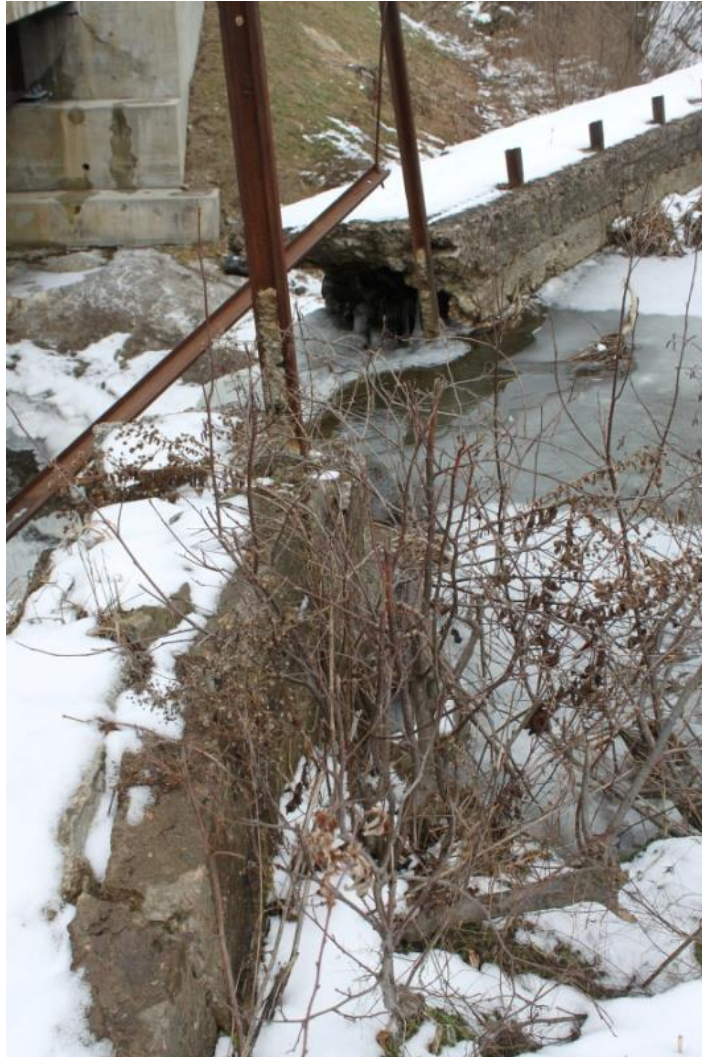
To the left (west) of the principal spillway section, is the left wing and abutment (Figure 31). According to historic images and earlier surveys, the left wing was once 46.5 ft long and composed of a substantial stone wall about 3.5 ft wide at the stream side and about 3 ft wide at its far end (Barranco 1980; Dubois & King 1990: Plate #2 and #3). Presently, only about 12 feet of the wing can be traced. Most of this structure appears to have been buried by road construction in 1982 and 2015 (Barranco 1980; VTrans 2014). Sometime in the early 20th century a concrete cap, up to 4.5 ft thick was added to the left wing, however, this feature was lowered about 2 ft when the road was widened in 1982 (Barranco 1980; Dubois & King ca. 1989; Dubois & King 1990: Plate #2 and #3; Milone & MacBroom 2018). Also, according to earlier surveys, there was once a short concrete training wall with a 1 ft wide crest that extended about 9 ft upstream from the end of the left wing (Dubois & King 1990: Plate #2).

Figure 31. View east across the top of the left (west) wing (foreground) of the Mill Pond Dam.

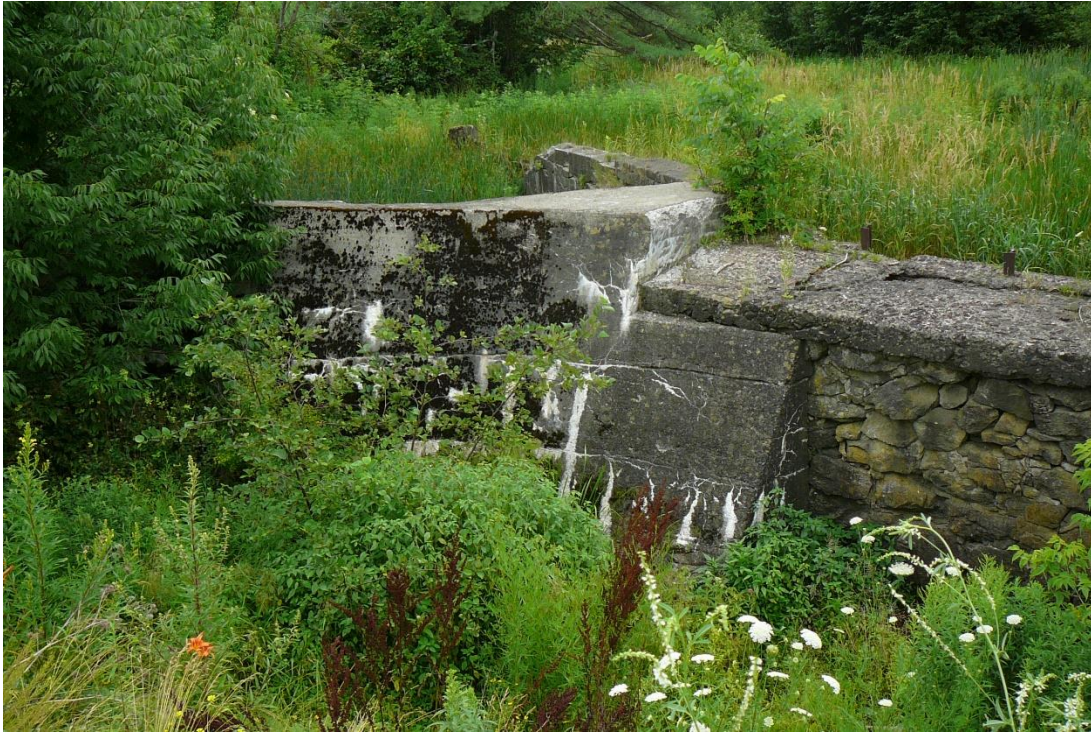
The entire right (east) wing of the dam, to the east of the stone masonry section, is a large truncated Y-shaped concrete structure consisting of a substantial mass concrete section and a possible ‘training wall’ section, which come together to form a socket around the right end of the stone masonry section (Dubois & King 1990: Plate #2) (Figure 32; see Figure 18). The mass concrete section appears to have been constructed at the same time, in December 1927. In places, the slight horizontal impressions made by the boards of concrete forms are visible on this part of the structure.

Figure 32. View southeast of the Y-shaped right (east) wing of the Mill Pond Dam; secondary spillway section (stone masonry portion) at right.

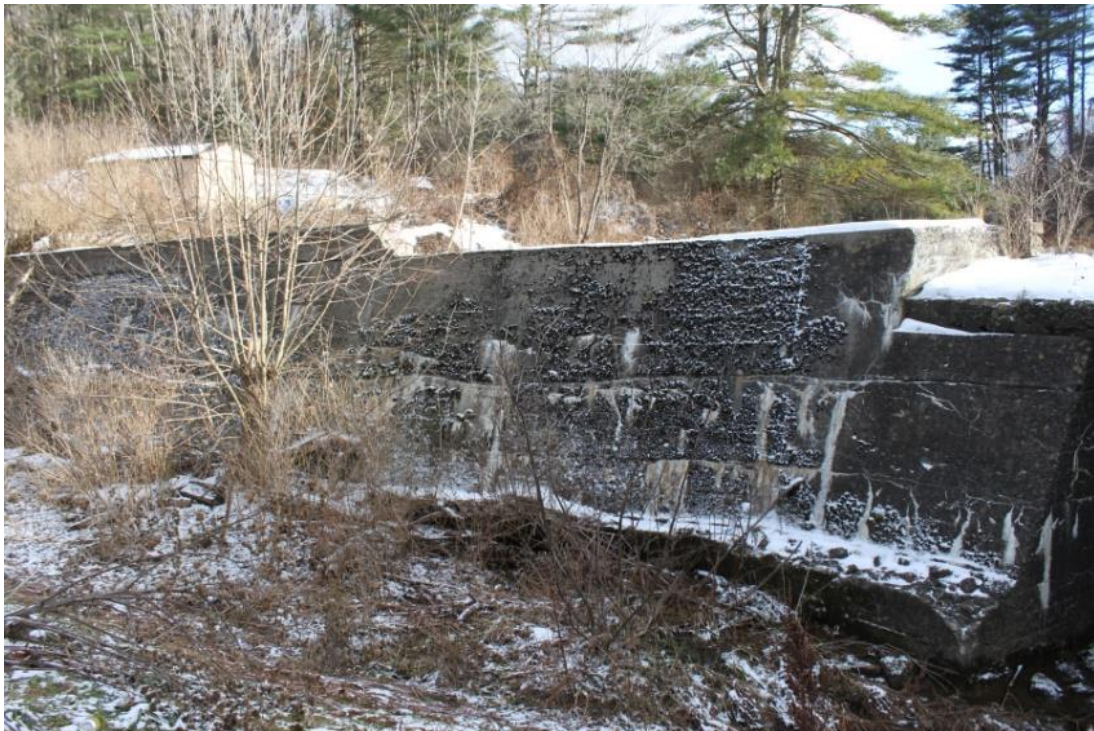
The downstream portion of the right wing is a concrete gravity dam that is buttress-like in cross-section (e.g. vertical upstream and angled or battered downstream) (Figures 33 – 35) (Dubois & King 1990: Plate #2 and #3). Overall, this section is about 60 ft long with a base thickness of about 8 ft (or more) (Dubois & King 1990: Plate #2 and #3). However, it has sub-sections having two different crest heights (Barranco and Fitch 1975). The more in-stream section is about 20 ft long and is about 1.5 ft higher than the secondary spillway (Dubois & King 1989; Dubois & King 1990: Plate #2 and #3). The remaining 40 ft, leading into the embankment, has a crest height about 1.55 ft higher (Dubois & King 1989; Dubois & King 1990: Plate #2 and #3). In this part of the structure, there is a distinct construction joint (a joint between two successive places or pours of concrete) visible between the base and the 1.55 ft high crest section. There is also a possible vertical construction joint between the 20 ft and 40 ft section. It is not clear how far the right wing is keyed into the bank. However, at the downstream side of

Figure 33. View east of the mass concrete section of the right (east) wing of the Mill Pond Dam.

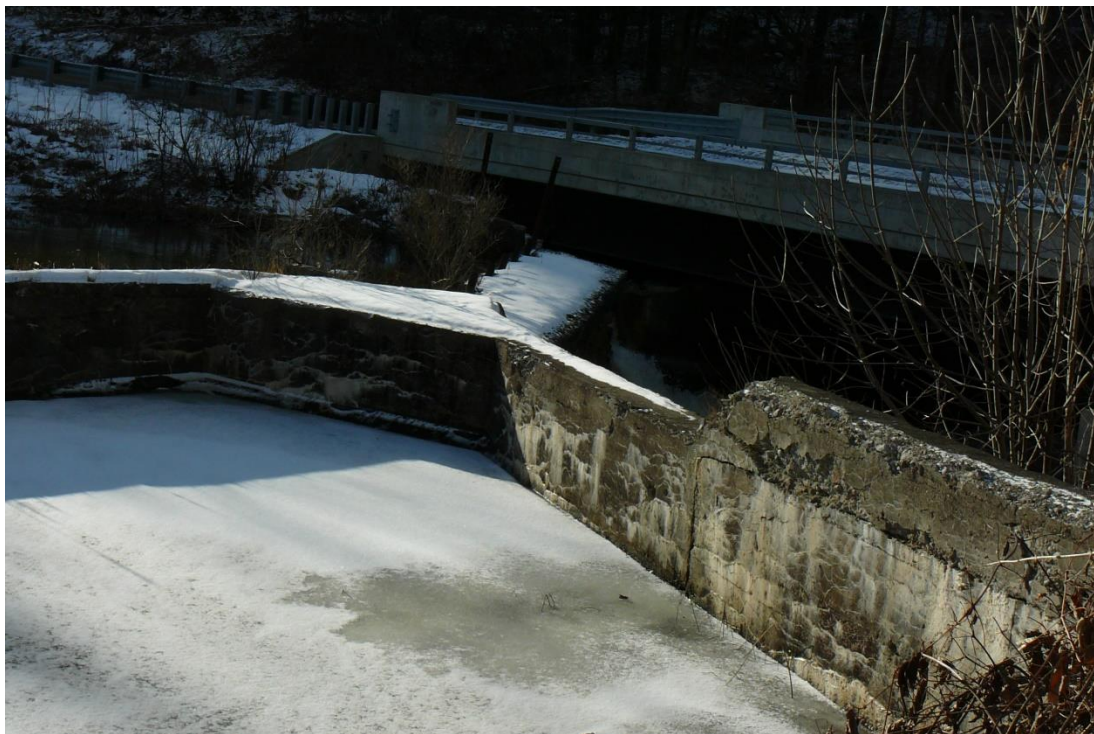
Figure 35. View northwest of the upstream face of the right (east) wing of the Mill Pond Dam.

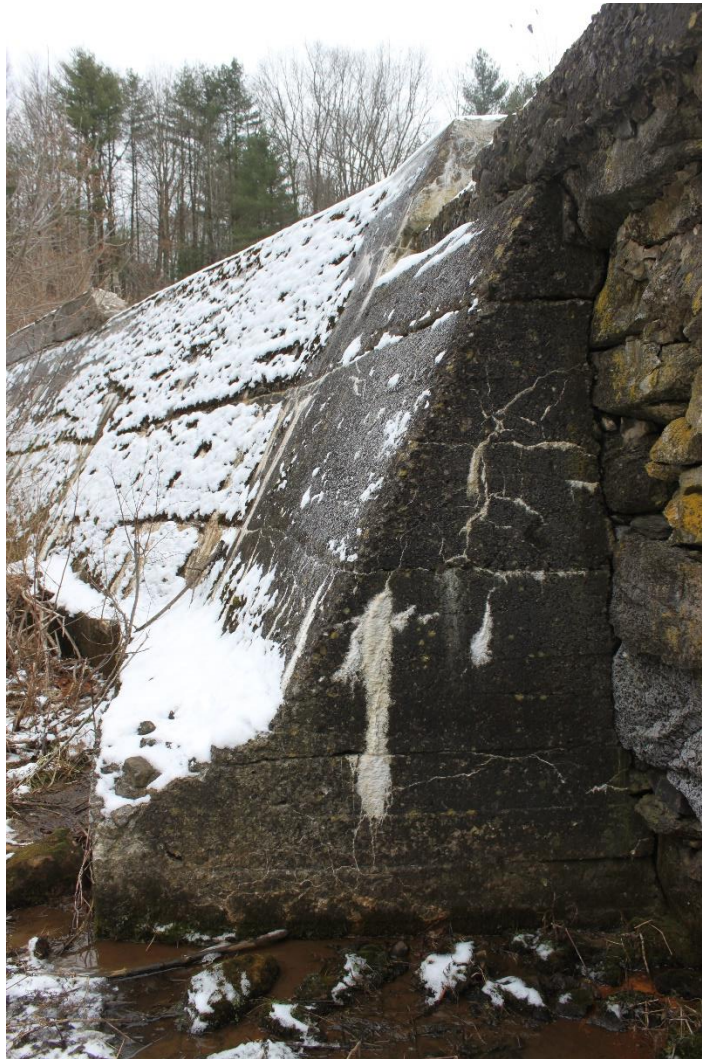
the east end of the wing there is a large concrete stepped baulk that is partially buried in the bank (Figure 36). The visible part of the baulk extends about 11 ft downstream and it is minimally 3.75 ft wide (Dubois & King 1990: Plate #2). At the west end of the mass concrete section, is the 5.3 ft of buttress-like section that stands on the downstream side of the central stone masonry section (Figure 37; see Figure 34). The contractor who removed the dam reported that the mass concrete section contained a lot of rock and contained no rebar (Figure 38).

Figure 37. View east of the concrete “buttress” at the junction between the stone masonry and the mass concrete sections of the Mill Pond Dam.
